Manhole Inspection Summary

Manhole # S47C__042MH

Insp Date: 7/14/08 11:22 AM

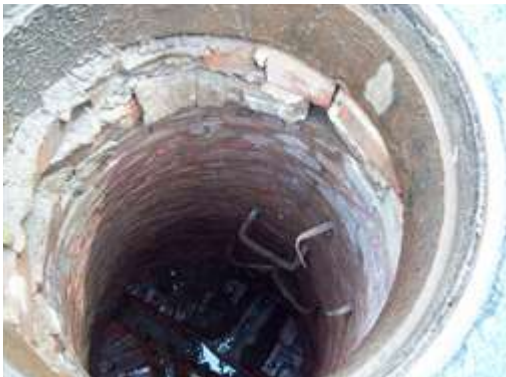
Defect 1

Frame Offset: **2** (in.) Condition: ☒ Sound ☐ Cracked ☐ Leaks

frame leaks

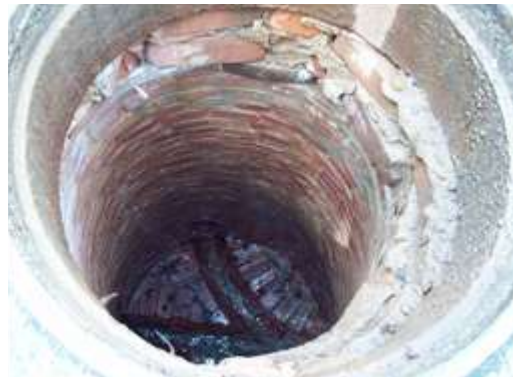
Defect 2

Condition: ☐ Sound ☐ Cracked ☐ Root Intrusion ☒ **Loose Brick** ☐ Deteriorated

Infiltration: ☐ None ☐ Joint ☐ Cracks ☒ **Mortar** ☐ Roots ☐ Wall

loose brick

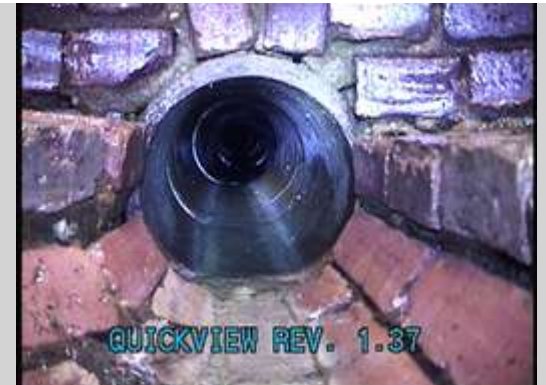
12 O'Clock Outflow

Pipe Height: **8.4** (in.) Rod and Bar (Angled)
Pipe Material: **Clay** ☐ Pipe Lined
Invert Depth: **11.05** (ft.) Flow Characteristics: **Fast**
Deposits: ☒ None ☐ Mud ☐ Sludge ☐ Debris ☐ Grease
Silt Depth: (in.) Deposits Extent:
Infiltration: **None** Pipe Seal Cond: **Sound**

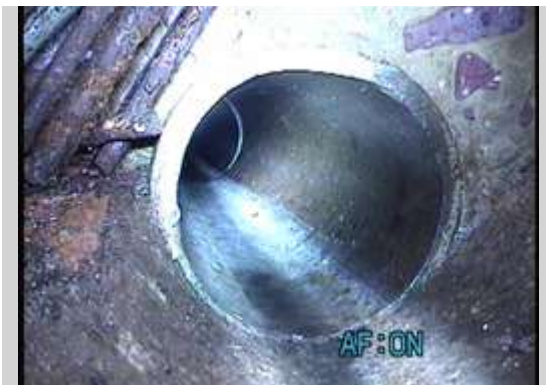
3 O'Clock Inflow

Pipe Height: **8.4** (in.) Rod and Bar (Angled)
Pipe Material: **Clay** ☐ Pipe Lined
Invert Depth: **10.80** (ft.) Flow Characteristics: **Fast**
Deposits: ☒ None ☐ Mud ☐ Sludge ☐ Debris ☐ Grease
Silt Depth: (in.) Deposits Extent:
Infiltration: **None** Pipe Seal Cond: **Sound**

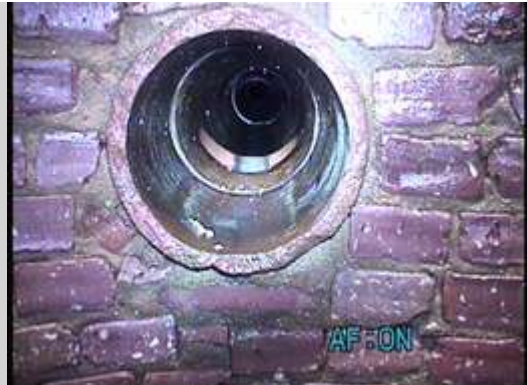
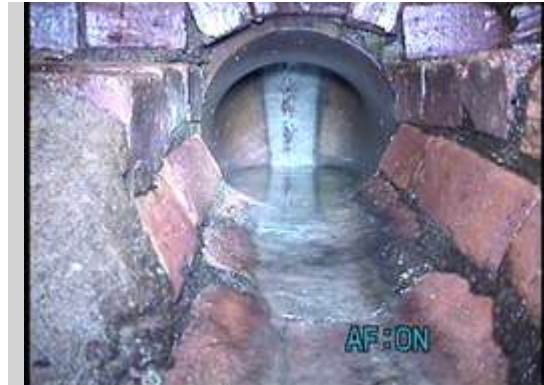
6 O'Clock Inflow

Infiltration: **None** Pipe Seal Cond: **Sound**

Drop: Inside	Rod and Bar
Angled: Yes	Reading: 9.95 (ft.)
	Inv Depth: 10.95 (ft.)
Drop Condition: Open

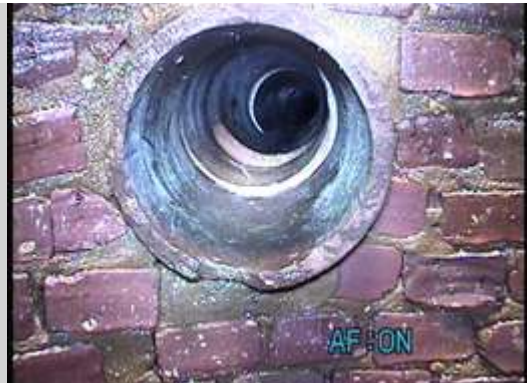
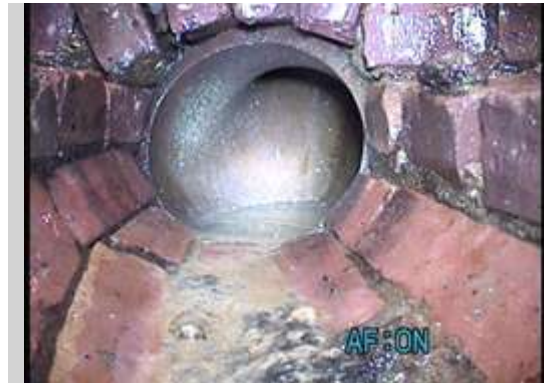
8 O'Clock Inflow

Infiltration: **None** Pipe Seal Cond: **Sound**

Drop: Outside	Rod and Bar
Angled: Yes	Reading: 9.95 (ft.)
	Inv Depth: 10.95 (ft.)
Drop Condition: Open
